Manhole Inspection Summary

Manhole # S45E__055MH

Insp Date: **8/14/08 9:19 AM**

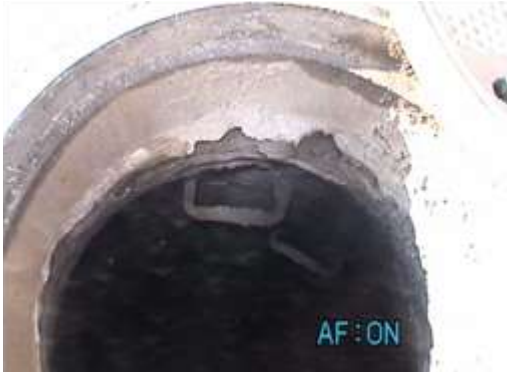
Defect 2

Infiltration

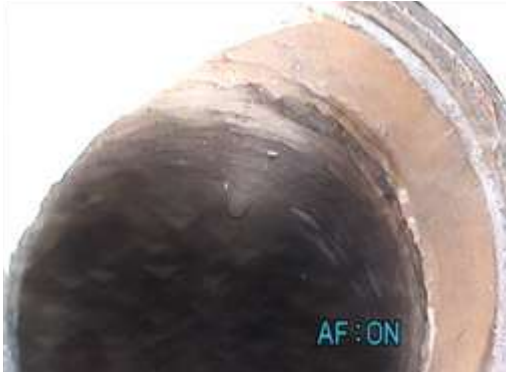
Defect 1

Frame leaks

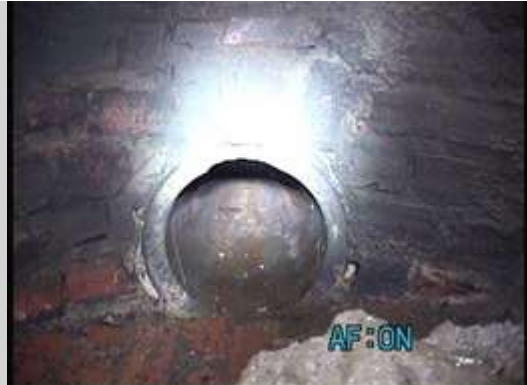
12 O'Clock Outflow

8 in. Circular Gravity Sewer
Pipe Out @ 12 O'Clock

Deposits: ☐ None ☐ Mud ☐ Sludge ☒ **Debris** ☐ Grease

Silt Depth: **0.15** (in.) Deposits Extent: **Light**
